# Rapid Technical Assessment of Damage and Needs for Housing Reconstruction in Tirrah Valley

**December 2013**

# **Executive Summary**

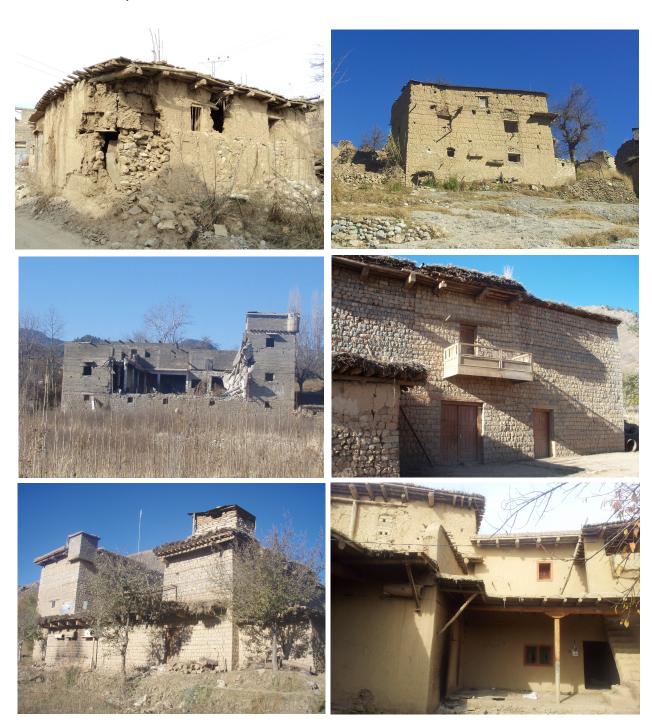
Most of the houses are multi-storeyed, 46% of the houses are double storey, 24% are three storeys while 30% are single storey. It looks like that the ground floor is constructed initially and more storeys may be added later as housing construction is usually incremental.

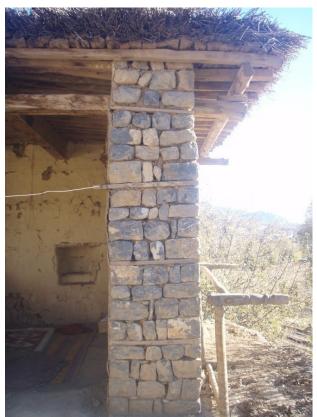
Thick Stone walls

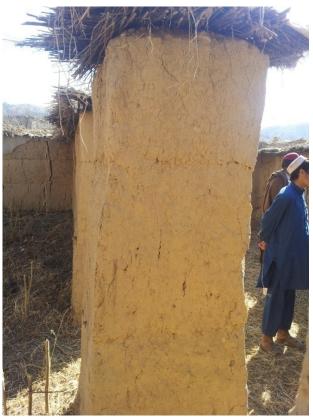
Thick mud walls

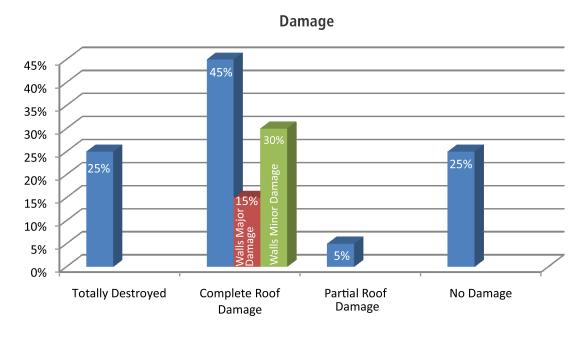
The above graph shows that 25% of the houses in surveyed area are completely damaged and another 45% are not liveable as their roofs are completely damaged while their walls are partially damaged. In addition to this, 5% roofs are partially damaged due to burning of some of the wooden beams or due to lack of maintenance. Remaining 25% are with no damage.
